# INVESTIGATION OF ENVIRONMENTAL IMPACTS ON SANDSTONE BLOCKS AT LUXOR TEMPLE AND CONCEPTS FOR CONSERVATION

**Dr. Elashmawy Abd -Elkareem Ahmed\***

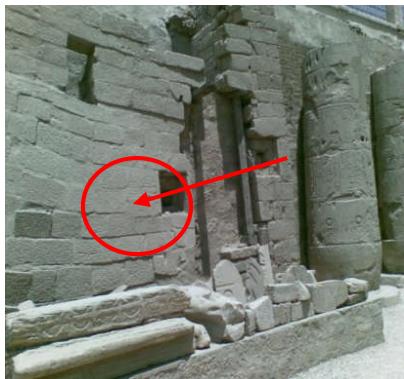
**Fig. (6) Differential tendency on the walls of Luxor temple**

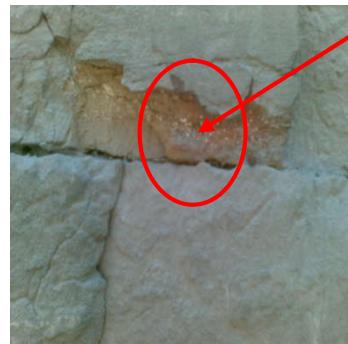
**Fig. (7) Stress on the lower parts of Luxor temple's walls**

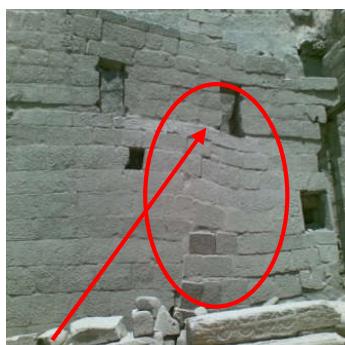
**Fig. (8) Differential tendency on the walls of Luxor temple**

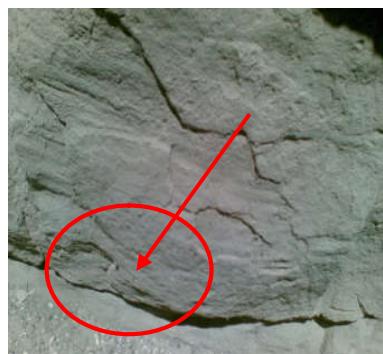
**Fig. (9) Soil on the lower parts of Luxor temple's walls**

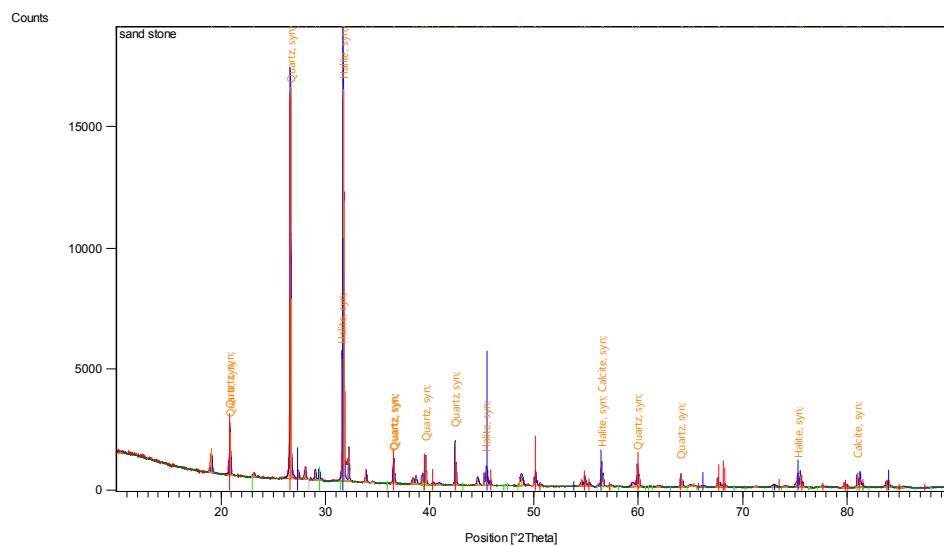
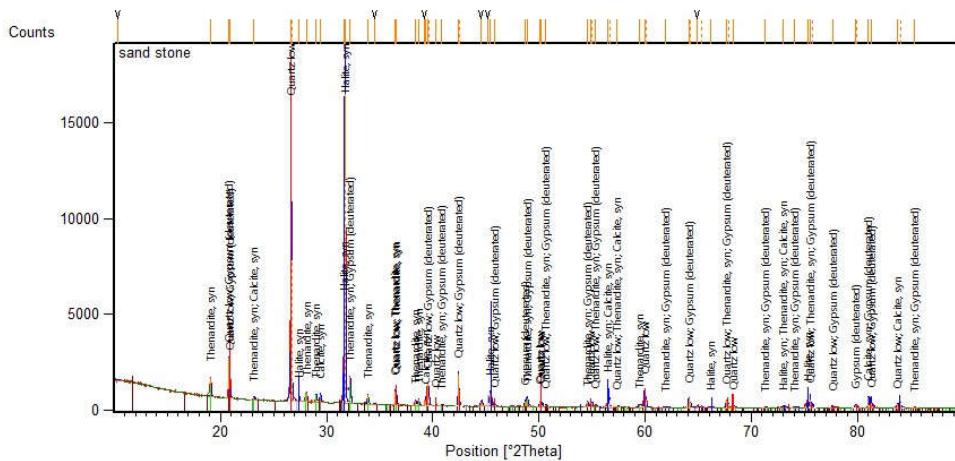
XRD patterns showed that quartz ( $\text{SiO}_2$ ) was the main component of the temple's sandstone, with subordinate amounts Calcite ( $\text{CaCO}_3$ ) and halite ( $\text{NaCl}$ ), thenardite ( $\text{Na}_2\text{SO}_4$ ) & gypsum ( $\text{CaSO}_4 \cdot 2\text{H}_2\text{O}$ ) (Fig.10 a & b). These results proved that the stone used in the temple was Nubian sandstone [37]. Damage to sandstone was caused by the mechanical stress, which was induced by halite, thenardite & gypsum crystallization cycles and calcite which may be cement in sandstone.

**Fig. (10 a&b) A sample of sandstone taken from Luxor temple analyzed by XRD.**

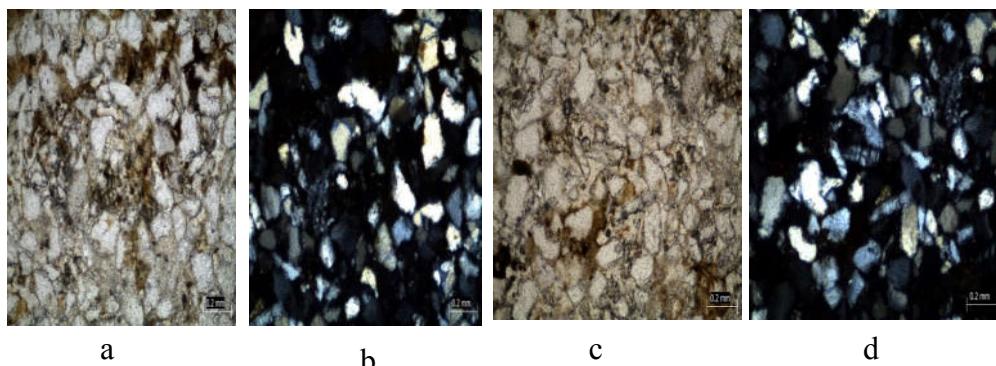
Samples taken from Luxor temple were examined under the polarized microscope and showed that, the percentage of quartz is the highest as it reached 94% and it took different forms. Other components were as follows: feldspar (5%), rock fragments (0.5%), and cement materials (10%). It was also found that the percentage of porosity and permeability was high [38] (Fig.11a, c). Some clay minerals (Fig.11a, c) and iron oxides were also found. Crystals of quartz appeared unequal in their dimension and volumes; they were of great and moderate granulation. Furthermore, it was indicated that angular quartz granules were transformed into semi-angular, showing that they didn't move far during the processes of deposition (Fig.11b, d). In other samples, quartz crystals were rounded and semi-rounded and they moved far during the processes of deposition. There was also an erosion of the edges of some crystals and that extended to the interior part. These results were supported by XRD examination showing that quartz was the main compound with little percent of salts (halite NaCl).

**Fig. (11) A sample of sandstone from Luxor Temple X25**

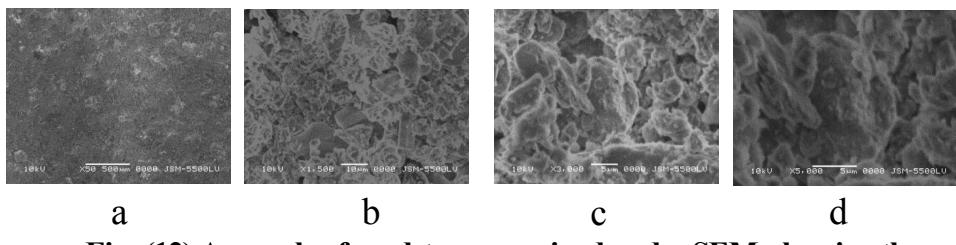
The samples studying by SEM were identified as quartz ( $\text{SiO}_2$ ) (Fig.12a.b.c.d) and other salts were submitted by XRD and EDX and XRF such as halite ( $\text{NaCl}$ ) and gypsum ( $\text{CaSO}_4 \cdot 2\text{H}_2\text{O}$ ) and notice decayed of grains of quartz (Fig.13 a.b.c.d). Samples show a damage of cement materials and a breaking in the granules of sandstone (Fig.12a, b). Other samples show a differential of quartz grains, and a collapse of the stone's internal structure (Fig.13c,d).

**Fig. (12)** A sample of sandstone examined under SEM, showing the

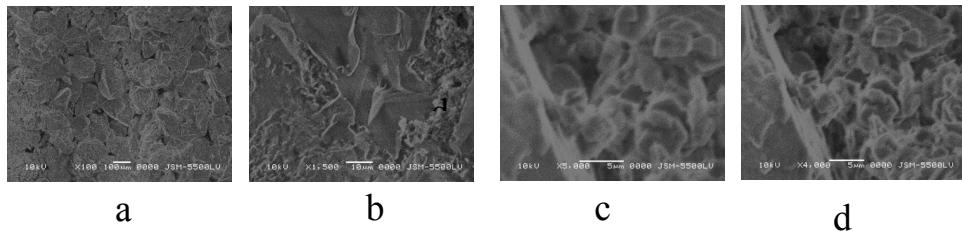
**Fig. (13)** A sample of sandstone under SEM, illustrating the damage of cement materials and the differential of quartz grains form

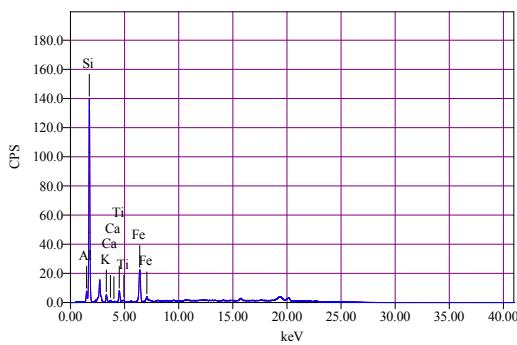
EDX micro analytical methods were conducted to identify the samples and evaluate their components which indicates that the elemental arrangement of the samples collected from different places could be put in a decreasing order according to their concentration as follow: Si(78.92-85.89%), Al (6.09-7.15%), Fe (5.81-2.56%), K (4.65-1.95%), Ti (3.77-2.06%) and Ca (0.76-0.39%)(Fig.14) (Tab.1) This helped in understanding the weathering mechanisms affecting the temple, in second sample Si(77.12-84.32%), Al (6.94-8.09%), Fe (6.44-2.88%), K (4.32-1.84%), Ti (3.93-2.28%) and Ca (2.24-0.59%) (Fig.15) (Tab.2). The first and second samples contained Si (as the main component). However, the absence of chlorine (Cl) and sodium (Na) indicated the non-crystallization of halite on the wall reliefs. The analysis also indicated a low concentration of calcium (Ca) that indicated the existence of gypsum and anhydrite salts on the sandstone. In addition, the moderate amount of Aluminum (Al) and potassium (K) could be attributed to feldspars and phyllosilicates. On the contrary, the presence of relatively high amounts of iron and small amounts of titanium was attributed to the origin of these samples, atmospheric pollution and presence of accessory minerals such as Fe – Ti bearing phases; they played a significant role in deterioration.

Fig. (14): EDX spectrum of the sandstones (under study)

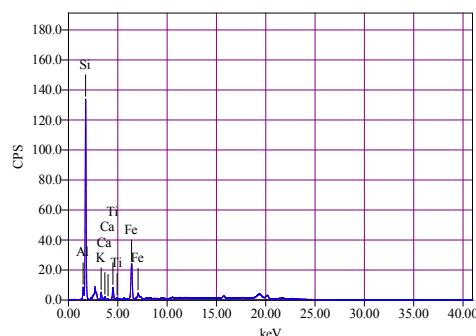
Fig. (15): EDX spectrum of the sandstones (under study)
